The TRIUMPH Corporation

SERVICE BULLETIN

67/8

SUBJECT: Comprehensive Test and Troubleshooting Instructions for all 6 and 12 Volt Battery Ignition Models ("B" & "C" Range from 1963) using Lucas RM19 A.C. Equipment.

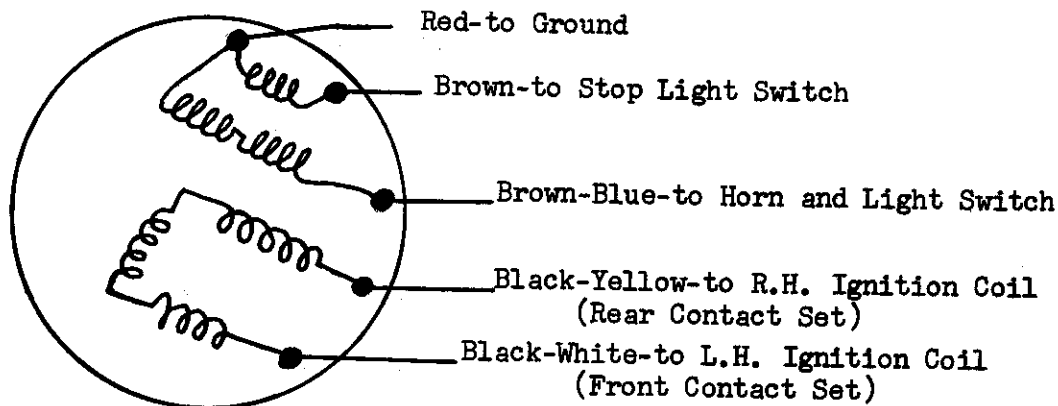
The internal stator connections shown in Fig. H29 (on page H27) apply to
the earlier 47188 stator. The NEW encapsulated stator, part number 47197,
has revised internal connections as shown in the sketch below.

Note that the Brown wire to the stop light is no longer connected to the
ignition windings.

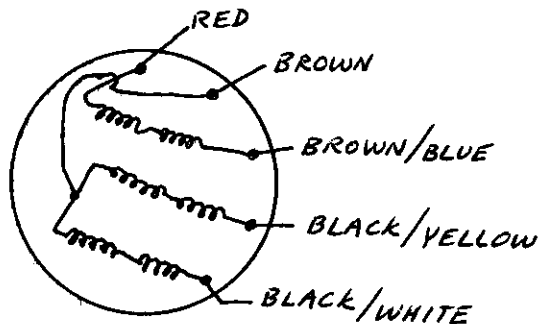
47188 STATOR

SHORTED WINDING TEST:

1. There should be no continuity between any stator lead and the metal stator frame or a good clean ground on the engine.
2. There should be no continuity between the Red or Brown/Blue lead and any of the other 3 leads (Brown, Black/Yellow, or Black/White).

By performing the above tests, you have checked the complete stator (both ignition and lighting windings) for shorts and opens. If the stator fails any one of these tests, you must replace it before proceeding further.

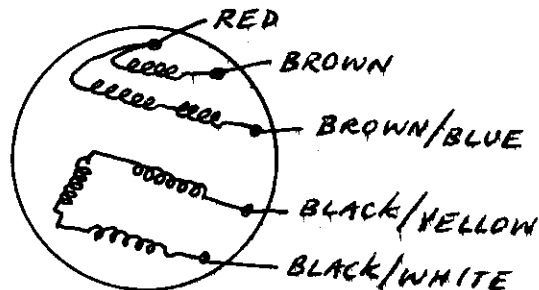
47197 STATOR

SHORTED WINDING TEST:

1. There should be no continuity between any stator lead and the metal stator frame or a good clean ground on the engine.
2. There should be no continuity between a Black/Yellow or Black/White lead and any of the other 3 leads (Brown, Brown/Blue, or Red).
