# The TRIUMPH Corporation

## SERVICE BULLETIN

67/9

SUBJECT: Tachometer Drive Thimble Replacement

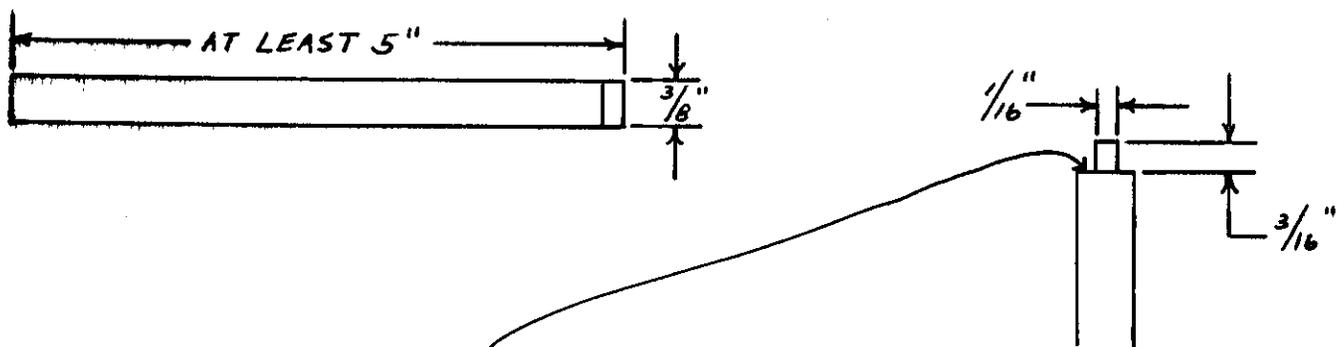
This face must be square with the axis of the drift.

- 1) Remove the tach drive gearbox or the cable adaptor from the crankcase.
- 2) Using a  $3/8$ " pin punch, drive the old tach drive thimble (E4700) at least 1" into the exhaust camshaft. The exhaust camshaft is not hollow all the way thru and the old thimble will not be able to get out of the camshaft once the complete repair job is effected.
- 3) The drive thimble ears that are broken off when the thimble is punched into the camshaft should be retrieved with a magnet if possible.
- 4) Thread the new repair drive plug (E7050) thru the threaded tach drive hole in the crankcase and into the camshaft as far as possible.
- 5) Using a drift constructed as shown below, drive the E7050 drive plug into the camshaft until it is just flush with the end of the shaft. Be careful not to drive this plug in too far as the drive gear blade must be engaged adequately with the drive plug slot.
