The TRIUMPH Corporation

SERVICE BULLETIN

67/8

SUBJECT: Comprehensive Test and Troubleshooting Instructions for all 6 and 12 Volt Battery Ignition Models ("B" & "C" Range from 1963) using Lucas RM19 A.C. Equipment.

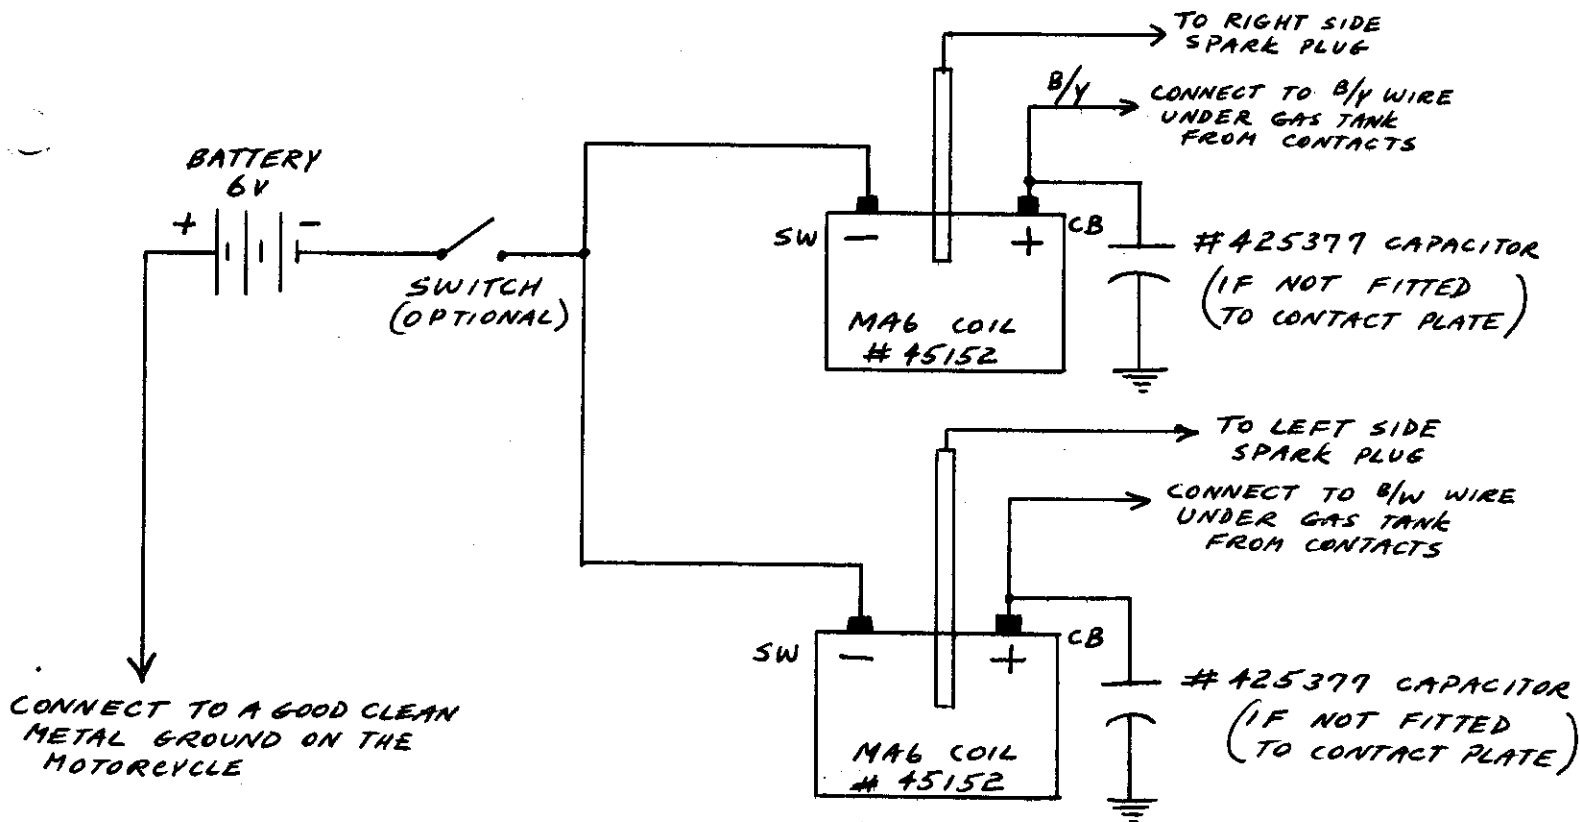
IMPORTANT -- Run the engine only long enough to make the necessary test readings with this "power pack." The MA6 ignition coils are not designed to be run with such a long dwell ignition cam as the A.C. ignition cam. The long dwell will cause excessive current in, and overheating of the primary winding of the 6V coils.

To perform this test, you must make up a "power pack" to run the engine on while the stator is disconnected from the ignition system. Complete instructions are to be found in the CD411 or CD446 workshop manuals; however, the simple diagram for this "power pack" is shown below. It will be easy to construct the "power pack" from this diagram.

USE 16ga WIRE
